### THE PETROL INJECTION METERING UNIT: TIMING AND FITTING PEDESTAL SEALS

#### 1. REPLACING SEALS IN THE METERING UNIT AND DISTRIBUTOR MOUNTING PEDESTAL

#### 2. TIMING THE PETROL INJECTION METERING UNIT

# AMENDMENT TO CHECK CARD No. 6

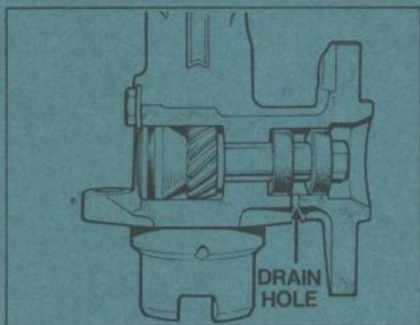
Two lip seals are fitted to the metering unit drive shaft in the pedestal housing. The two seals must be fitted with the lips away from each other; this prevents petrol leaking into the crankcase and also prevents oil entering the fuel metering unit in the opposite direction.

**NOTE:** The last seal to be fitted must not be pressed too far into the housing, see illustration, otherwise the drain hole in the pedestal will be blocked.

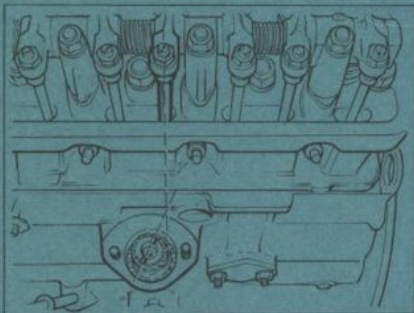
The distributor and metering unit drive gear must be fitted in the block so that the large offset of the distributor drive shaft faces the rear and the slot is pointing towards No. 9 push-rod.

The gear must also mesh with the camshaft gear and the slot on the bottom end of the spindle engage with the oil pump drive.

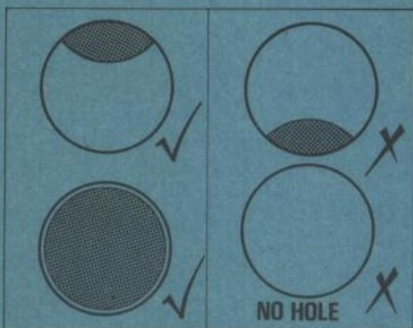
the metering unit to check position of the hole in the rotor. The hole should be visible as an eclipse at the top as shown in the illustration.

A full hole is acceptable.  
An eclipse showing at the **BOTTOM** is **INCORRECT**.  
No hole visible is **INCORRECT**.

If the eclipse is not showing in the correct position, lift the pedestal and metering unit sufficiently to allow the drive gear to clear the camshaft gear.

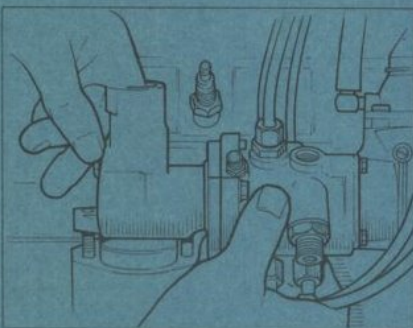
Place fingers in distributor hole of pedestal and turn gear anti-clockwise (towards engine) one tooth.  
At this point no hole is visible through metering unit hole.  
Rotate gear anti-clockwise one extra tooth and lower pedestal and metering unit into position.

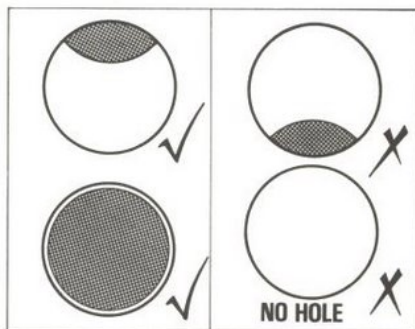
Injection is now timed for 30° after top dead centre (A.T.D.C.) and can be checked as follows.

(The tolerance for injection timing is 20° A.T.D.C. to 45° A.T.D.C.; the marks correspond to these two angles.)

4. Remove No. 6 injector pipe and adaptor union.
5. Continue to turn the engine in a clockwise direction until a small eclipse is visible in the No. 6 adaptor hole; at this point the crankshaft must be between 20° A.T.D.C. and 45° A.T.D.C.
